Lake Windermere

Aquatic Invasive Plant Sampling

2015

Prepared for the Lake Windermere Ambassadors

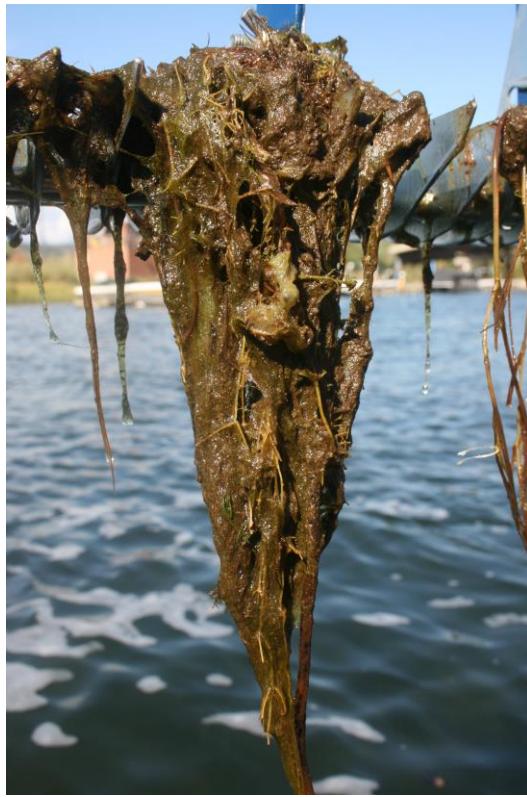
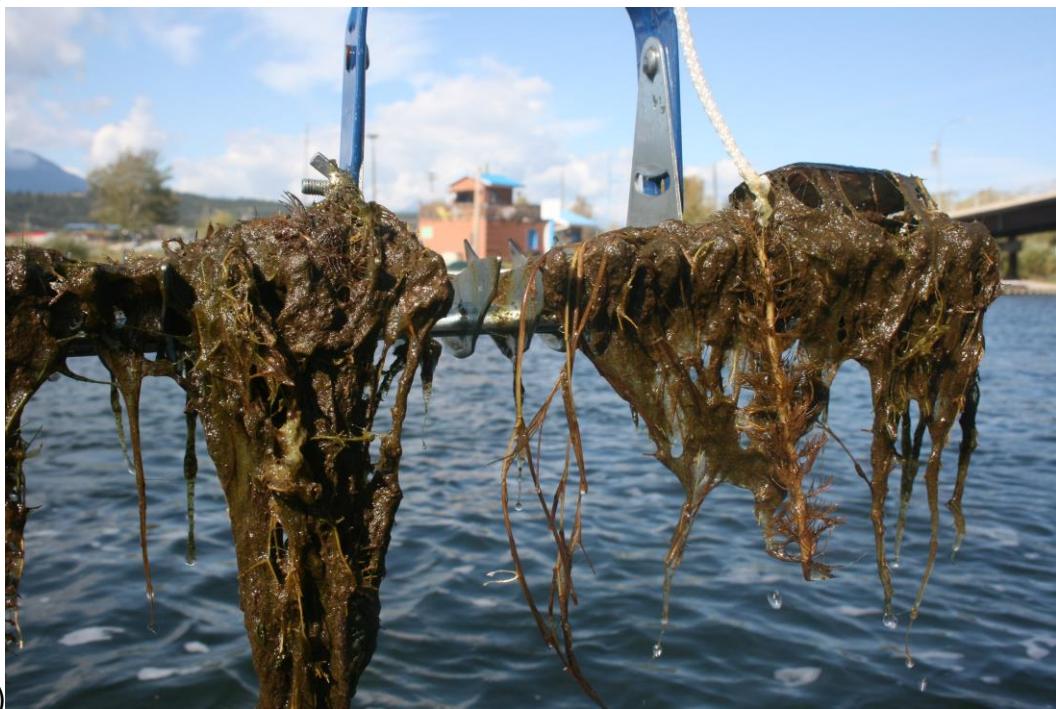
One unknown microfilamentous algae species was detected at two locations and collected for future identification; it was found attached to rocks along the rock weir south of Althalmer and attached to native aquatic plants in front of the Althalmer Boat Docks/Pete's Marina (see Figures 1a and 1b); the busiest public boat launch location on Lake Windemere. One specimen was collected at each of two sites, they were wrapped in damp paper towels within a ziplock bag and placed into a cooler on ice. The samples had had the collection date, collector name, water body name, UTM coordinates listed with permanent marker. Later that day, the samples were dried and subsequently sent to Linda Jennings at the Beaty Biodiversity Museum for identification.

Figure 1a and 1b. Unknown filamentous algae collected with a thatch rake in front of Athalmer/Pete's Marina

Linda Jennings is not sure of its species identification. Multiple experts were sent photographs of the specimen, but no positive ID has come back leaving inconclusive results for what this microfilamentous algae is. The images went to the following aquatic plant specialists: Frank Lomer, Adolf Seska, Chris Harkness, Becky Brown, Gisele Mitrow. One response came from Paul Hamilton (personal communication, October 13, 2015) from the Phycology Museum of Nature in Ottawa whom stated:

"It is hard to tell without a microscope examination of the filaments. It is a green filamentous alga, likely Oedogonium. If you can send me a picture of the filaments under a microscope, I can make a better identification."

Additionally, Thomas Woolf (personal communication, September 22, 2015) suspects that the algae is a result of the warm and sunny summer that we've had. Woolf suggests that in the fall the native plants start to senesce and release nutrients as they degrade. This can trigger algae blooms, especially if the water is still warm in combination with sun. Woolf reported seeing quite a bit of algae late in the 2015 field season in Idaho, he thought that was a result of a very warm summer.

In regards to the unknown filamentous algae, it is suspected to be *Oedogonium*. This is a commonly found filamentous green-algae that can be found either attached to other plants (as was the case at Althalmer), or it can be found free-floating. However, this has not been previously detected in Lake Windermere, so it would good to monitor this species distribution and abundance in subsequent years. A study by McCracken, Gustafson, & Adams (1974) on *Oedogonium* found that, “algal mat development was related both to the presence of *Myriophyllum* and proximity to nutrient-rich runoff from storm sewer entries to the lake.” Since Althalmer is the busiest boat dock on Lake Windermere with a high level of human traffic, future monitoring efforts are warranted.
