Lake Windermere

Aquatic Invasive Plant Inventory 2023

**Prepared for the Lake Windermere Ambassadors
January 2024**

Prepared by Rachel Darvill, BSc., MSc., R.P.Bio

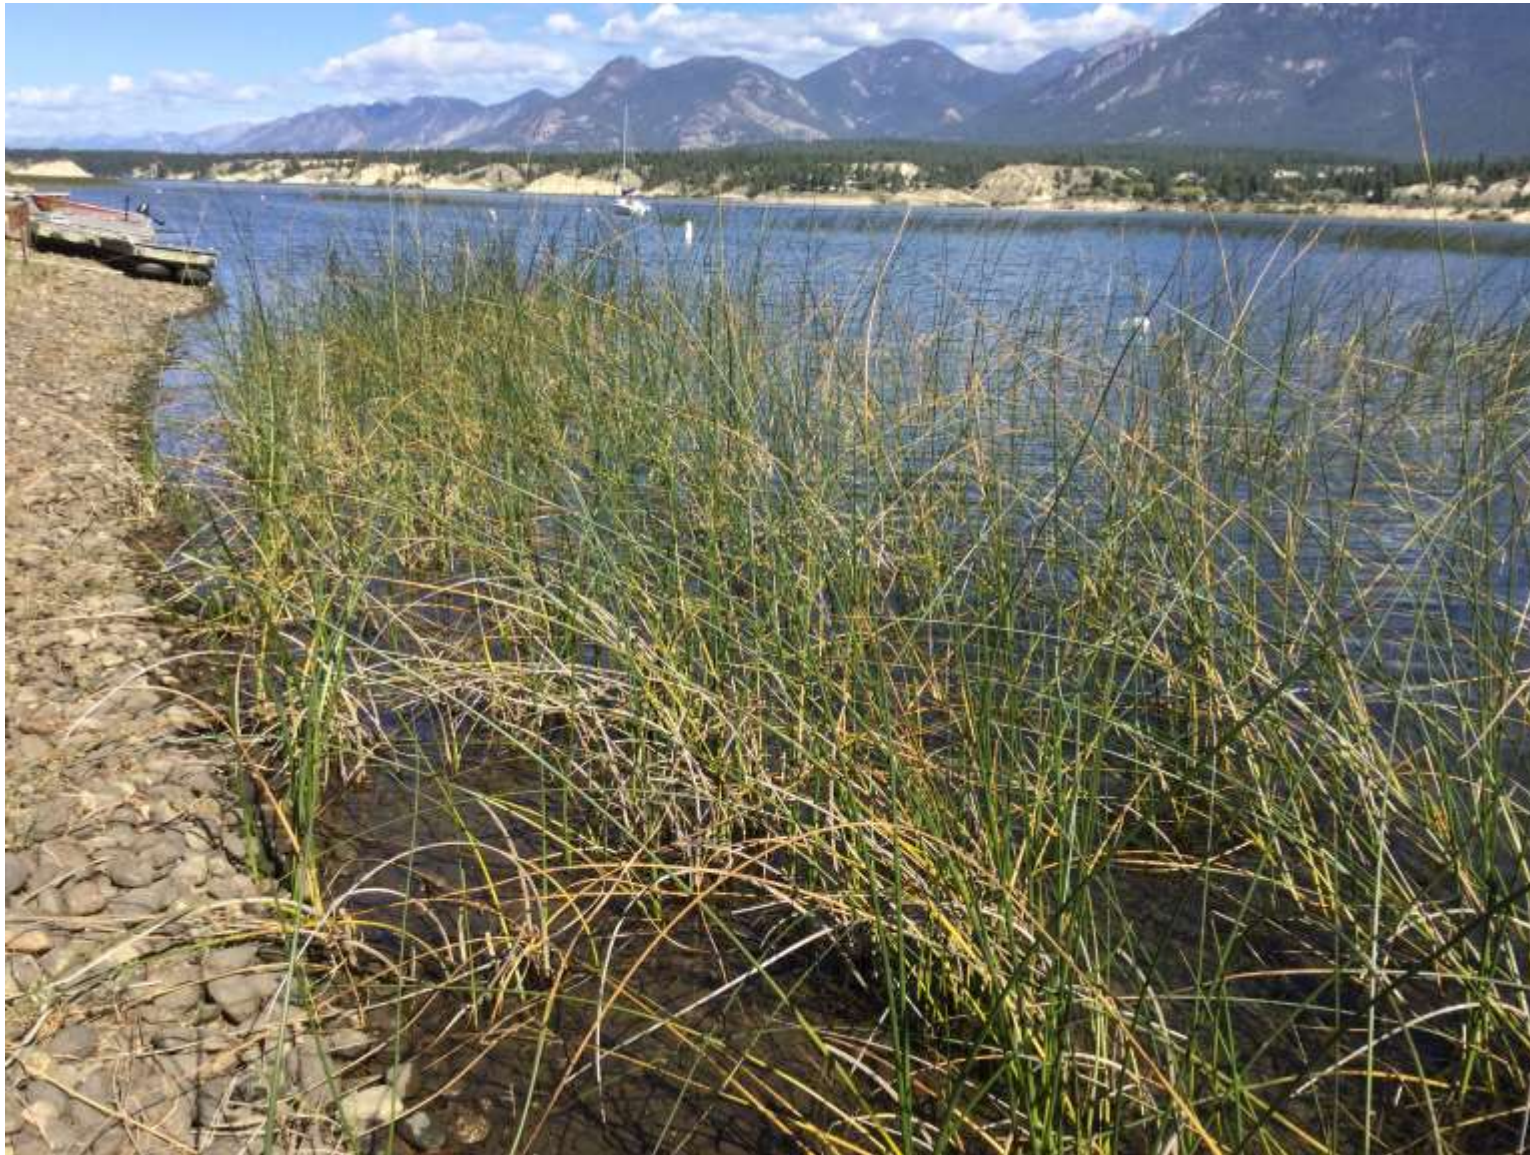
Figure 2. Provincially blue-listed (at-risk) hard-stemmed bullrush Deep Marsh ecological community occurrence at the Ruault Rd survey station, preventing access to the 50m north and 75m north sites.

Shoreline surveys were conducted at five locations or survey stations. The same stations were also surveyed in previous years of survey effort, with the exception of one station (Rushmere) that was not visited in 2022 or 2023 due to private property concerns. At two of the survey stations (i.e., Fairmont Side Channel, End of Ruault Road), it was not possible to sample at all seven sites per survey station due to private property and the obstruction of riparian vegetation (Giant Bullrush, a blue-listed and at-risk ecological community) (figure 2).

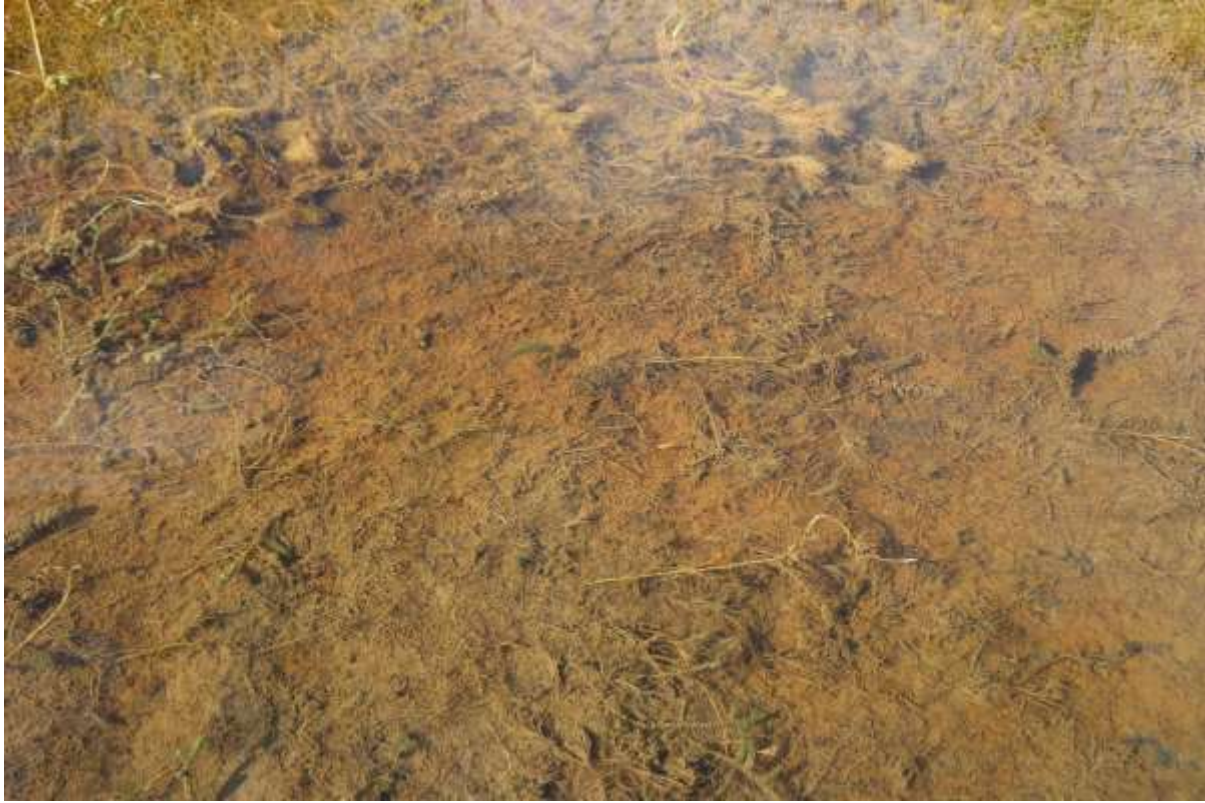
During aquatic plant surveys, in addition to unusually low water levels, an orange color was observed on the shoreline sediment at Pete's Marina/Athalmer (figures 3 and 4). Some of the aquatic plants at this location were also coated with sediment (figures 5) and there was a noticeable decrease in the abundance and diversity of native aquatic plants present at this station in comparison to all other years of survey effort. Other sampling stations continued to have a lack of abundant and diverse aquatic plant communities as was observed in previous years, such as Lakeshore Resort, Baltac Beach, Tretheway Docks and the 'unofficial boat launch near Bayshore Condos.'

Figure 3. Orange color of sediment and reduced amount of aquatic plants seen at shoreline of Pete's Marina.

In 2023, an unnatural coloration (orange) was observed along the shoreline of Pete's Marina/Athalmer (figures 3 and 4). This unnatural coloration warrants investigation to determine what is occurring to make those changes. Additionally, in 2023 as in previous years of sampling (Darvill 2022b, Darvill 2021), there was a noticeable lack of native aquatic plants at some sampling locations (e.g., Lakeshore Resort, Baltac Beach), and an observed decrease in the abundance and diversity of plants at some locations (e.g., Pete's Marina/Athalmer, Tretheway Docks). In 2023 it was observed that two of the survey stations (i.e., Tretheway Docks, Baltac Beach) had a thick and crusty coating of sediment on aquatic plants present at those sites.

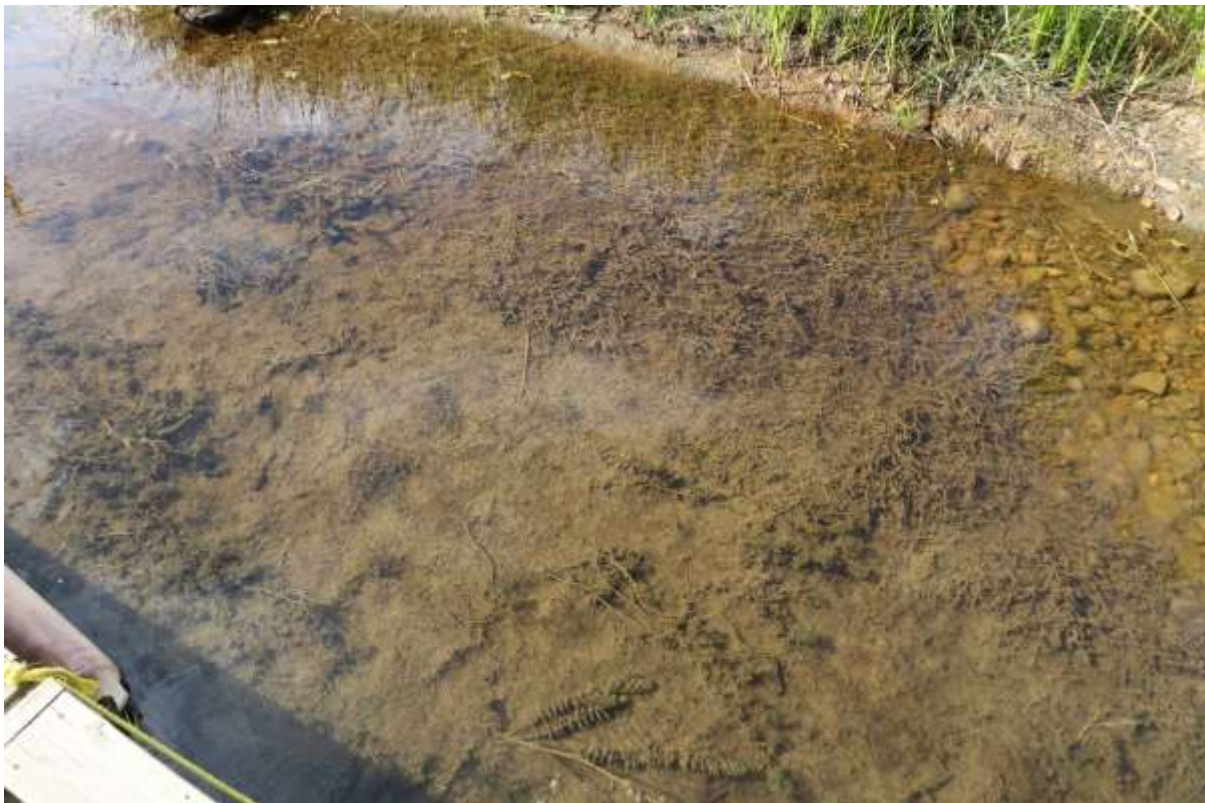
Figure 4. Orange color of sediment and reduced amount of aquatic plants on shoreline at Pete's Marina.

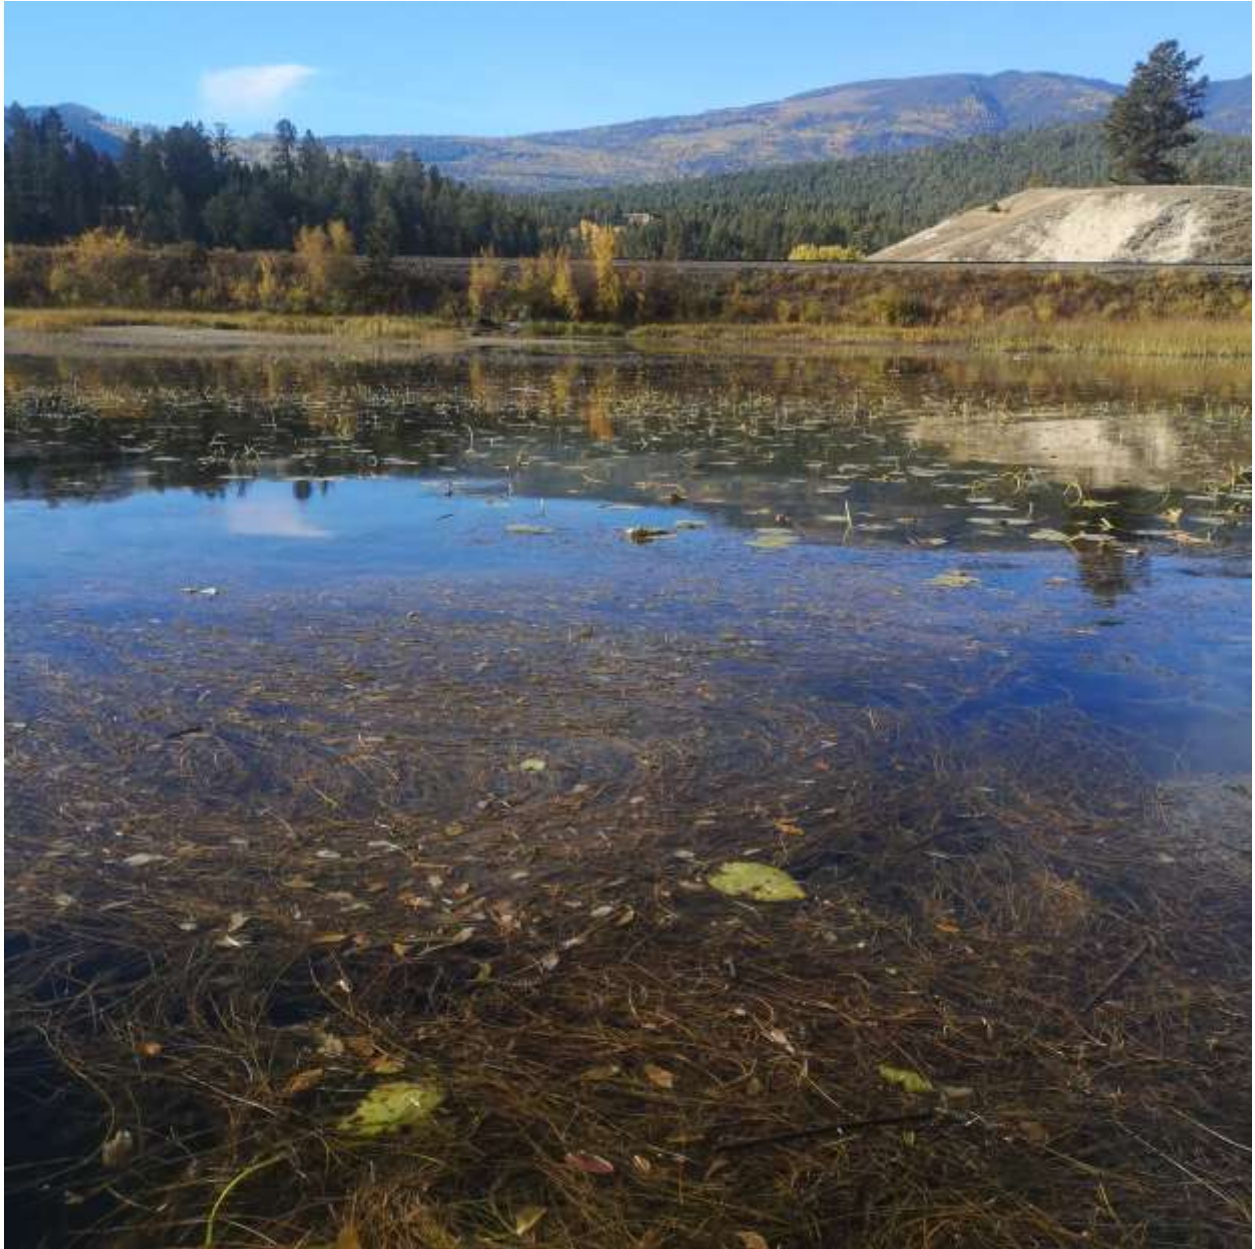
Figure 5. Abundant and diverse beds of aquatic plants at the Ruault Rd public access area, photo taken October 6, 2023.

There are certain areas of Lake Windermere that still hold diverse and abundant beds of native aquatic plants. It is recommended to evaluate the diversity, abundance and distribution of native aquatic plant species in the entire lake. Since maintaining native plant species is one of the major keys to keeping a lake healthy (Aron et al., 2008), it is recommended to designate special management zones for parts of Lake Windermere where plants are found to be either abundant or scarce. Van Nes et al., (1999) suggested that in areas where there are competing interests between nature conservation and recreation, that a compromise can be achieved by assigning certain areas of a lake to recreation and other parts should be left for nature conservation. For instance, Asplund and Cook (1997) found that “excluding motor boats from small experimental plots in a lake with heavy boat traffic significantly increased macrophyte biomass, coverage, and shoot height compared to impacted areas.” This is something to strongly consider. This should include the hard-stemmed bullrush Deep Marsh ecological communities on several sites along the shoreline of Lake Windermere. This ecological community is blue-listed in BC, meaning that it is at-risk in the province. It appears that none of the hard-stemmed bullrush Deep Marsh communities in Lake Windermere have been recorded into BC’s Conservation Data Centre database. It is recommended that these locations be identified and entered into the provincial database and into the regional Official Community Plan for Lake Windermere, and subsequently conserved.

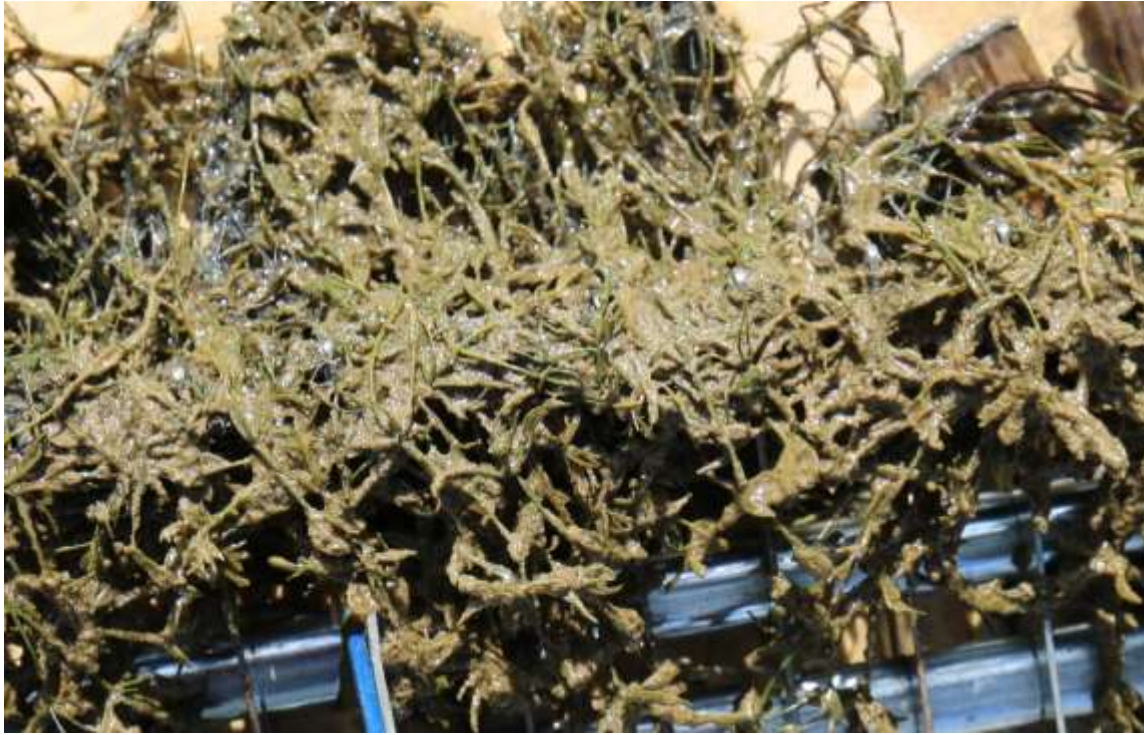
No aquatic invasive plant species were detected during offshore (boat) surveys. As with previous years of survey effort, abundant beds of diverse native aquatic plants were observed at the Ruault Road sampling site (figure 5). Consistent with past years of survey effort, some survey stations had a lack of abundant and/or diverse aquatic plant communities, such as Lakeshore Resort, Baltac Beach, the 'unofficial boat launch near Bayshore Condos' and Tretheway Docks. At two of the sampling sites (i.e., Tretheway Docks, Baltac Beach), a thick and crusty coating of sediment was observed to be coating the plants retrieved through rake tosses.

Figure 6. Thick sediment on *Chara sp.* at the Tretheway Docks, Windermere.

The accumulation of fine sediment are important in affecting the growth of submersed aquatic vegetation (Barko & Smart, 1986; Collins, Naden & Sear, 2012). A layer of deposited sediment will result in reduced photosynthesis and decreased growth of macrophytes (Collins, Naden & Sear, 2012). Barko and Smart (1986) have shown a demonstrated negative relationship between high sediment inputs on plants and the growth of submersed macrophytes, leading to a cascade of events. "Autumn/winter reduces the strength of macrophytes as they die back, which leads to increased likelihood of breakage or uprooting of macrophytes and the remobilisation of accumulated sediment, a process that is exacerbated by the lower stability and poor rooting medium presented by the accumulated sediment (Kleeberg et al., 2009)" (in Collins, Naden & Sear, 2012). As stands of submerged macrophytes grow the following spring, flow is directed into unvegetated areas where erosion of the lake bed occurs (Dawson, Castellano & Ladle, 1978; Kleeberg et al., 2009). Regrowth and occurrence of different macrophyte species is in turn influenced by substrate composition (highly influenced by

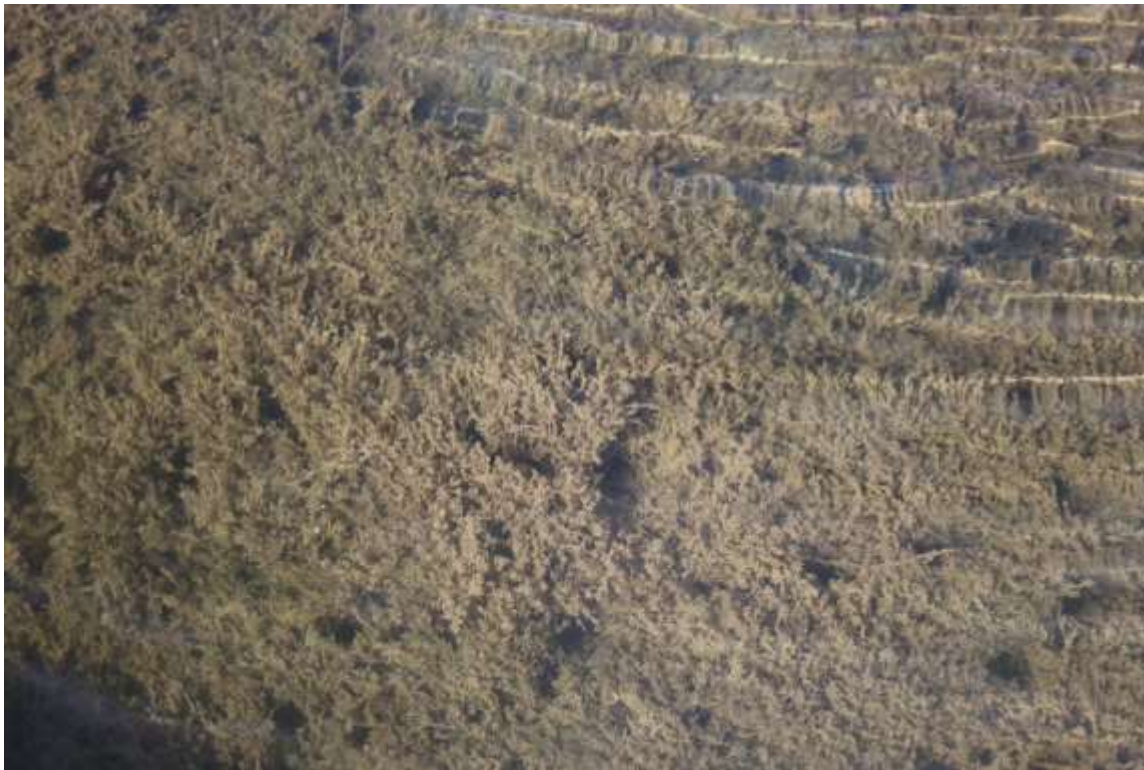
Figure 7. *Chara sp.* at Tretheway Docks, coating in sediment. Area lacking diversity of other macrophytic species (aquatic plants).
